MEMO TO FILE

The following information, Photos, has been separated from the rest of the original documents belonging to site, Bath Elec Systems (BES) ID # TXD065103327, because the material could not be stored at the Federal Records Center due to certain storage restrictions.

TDD# 06-8590-98 Pg. 1 of 20

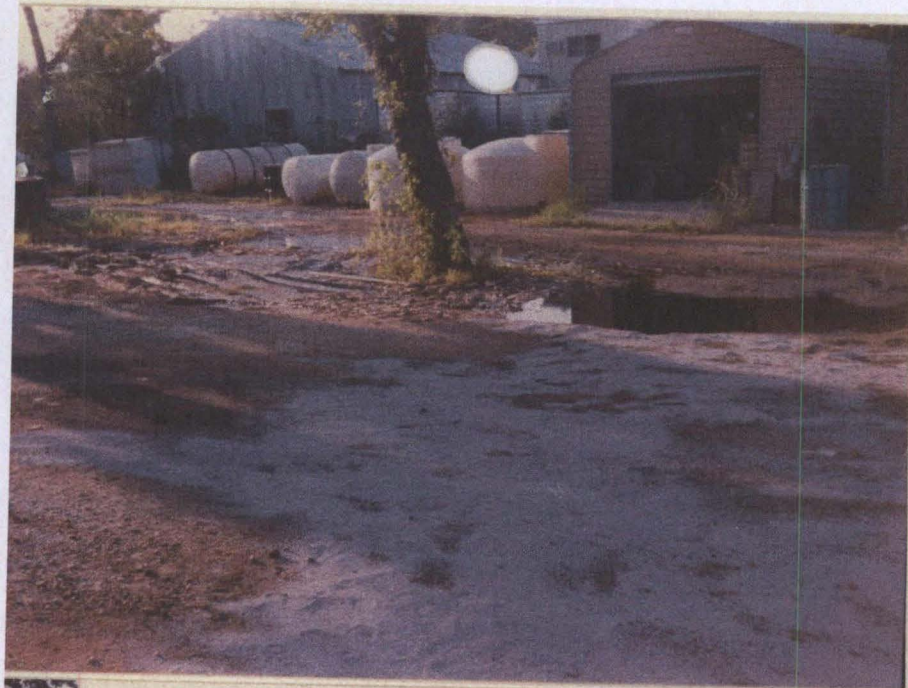
Photographer/Witness # 1

Comments: PCB oil on ground (BES
property) when TAT first arrived.

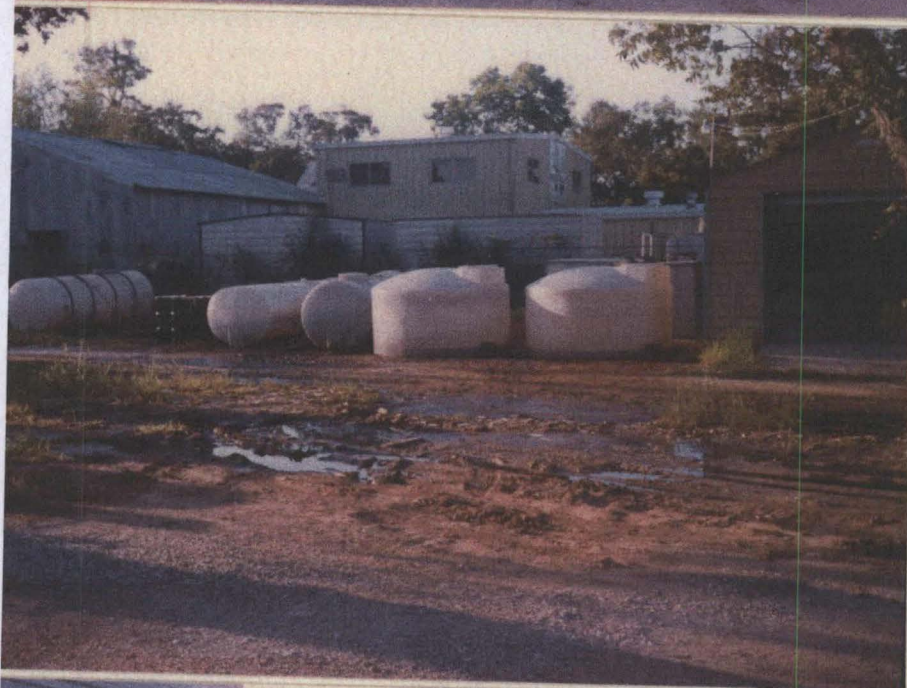
Photographer/Witness # 2

Comments: Tanks from which PCBs
were released.

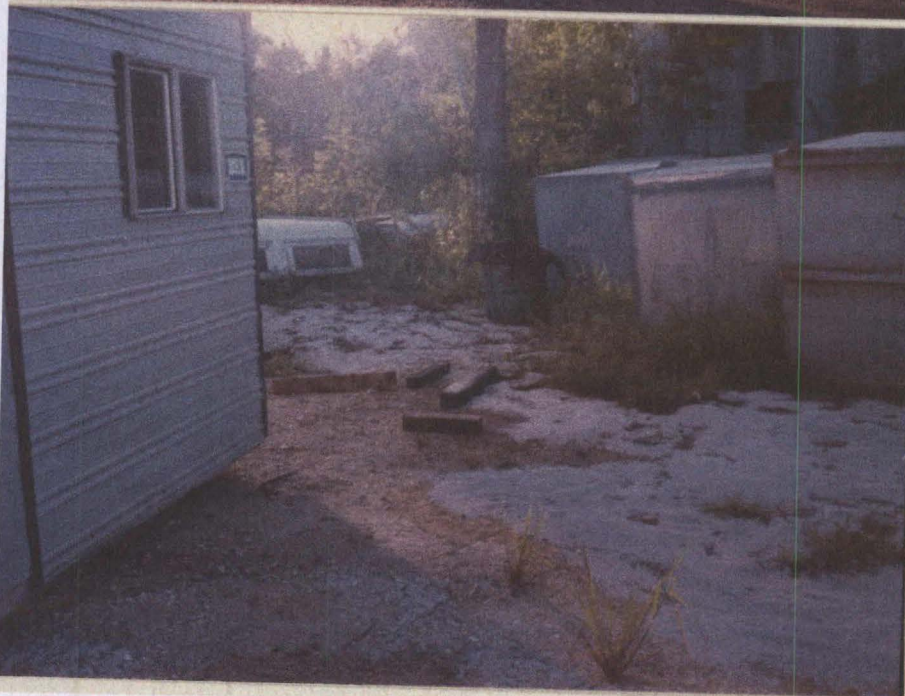
Photographer/Witness # 3

Comments: Path of PCB oil toward
residential area.

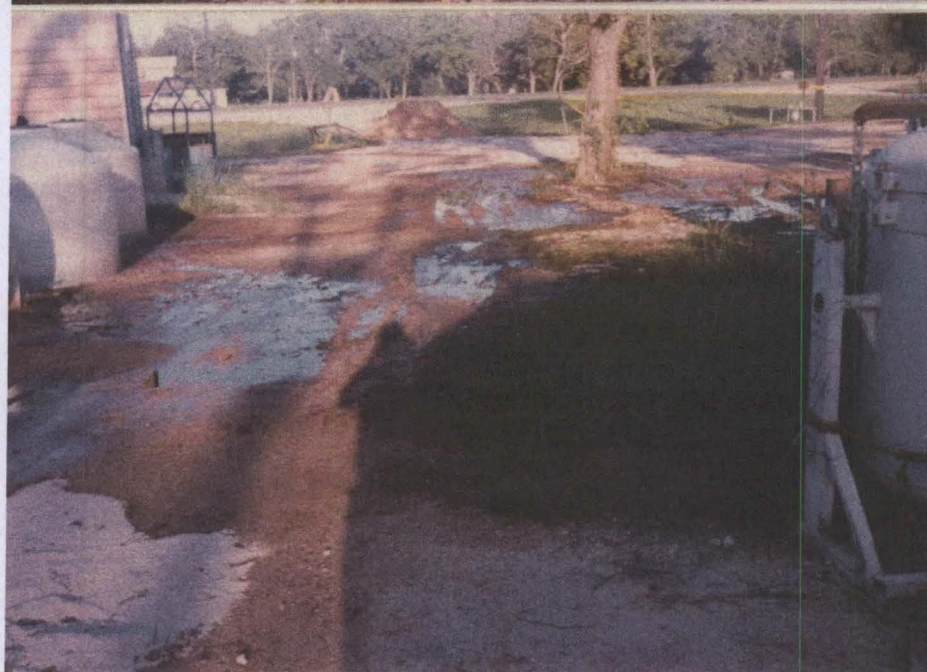
Photographer/Witness # 5

Comments: Runoff path to drainage
ditch.

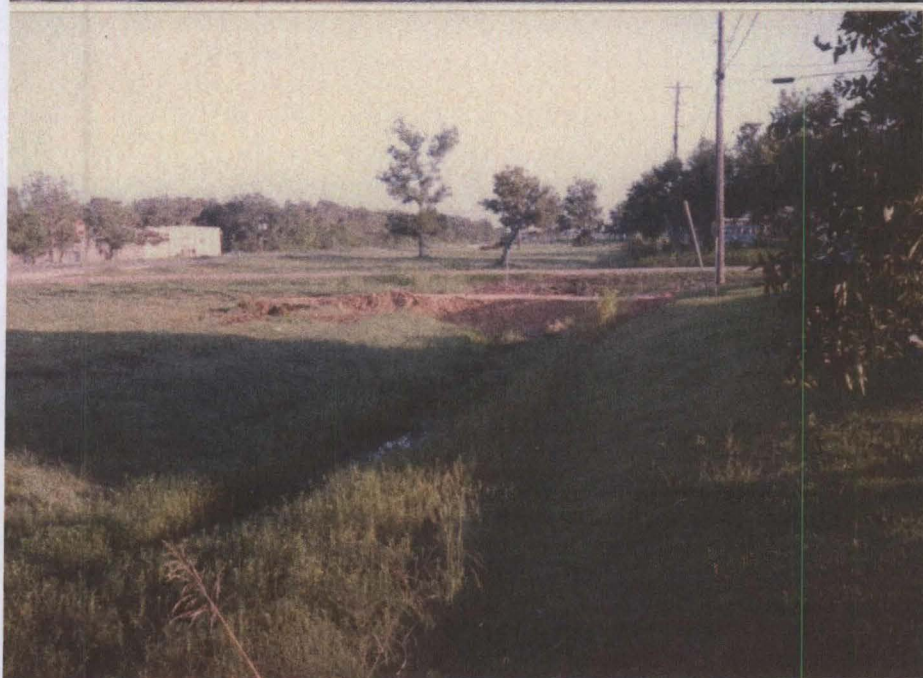
Photographer/Witness # 6

Comments: South end of ditch
dammed to prevent further movement
of PCBs in ditch.

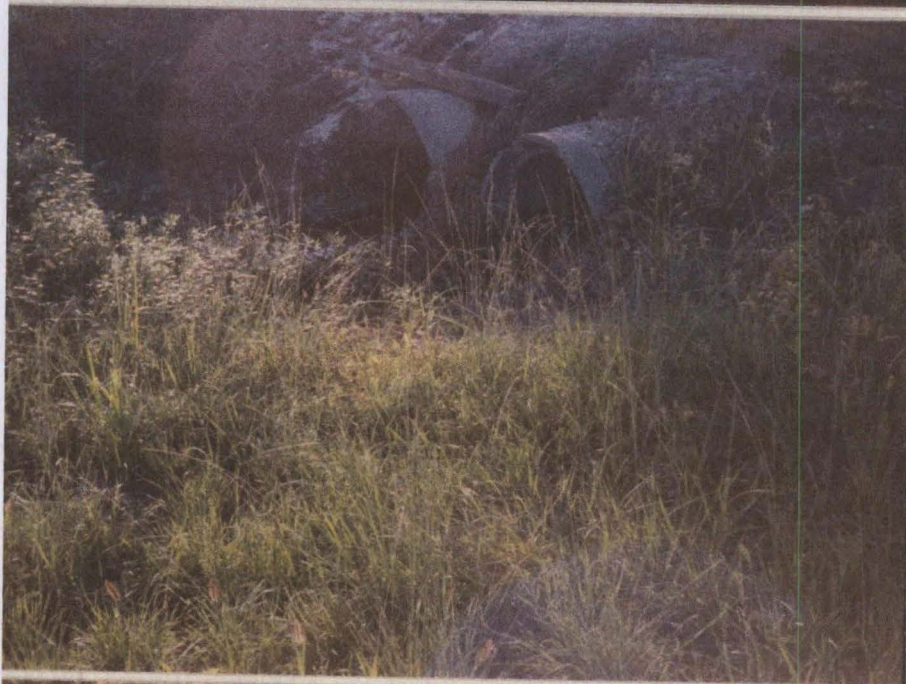
Photographer/Witness # 8

Comments: PCB oil in culvert.
Seven culverts were located within
the affected section of ditch

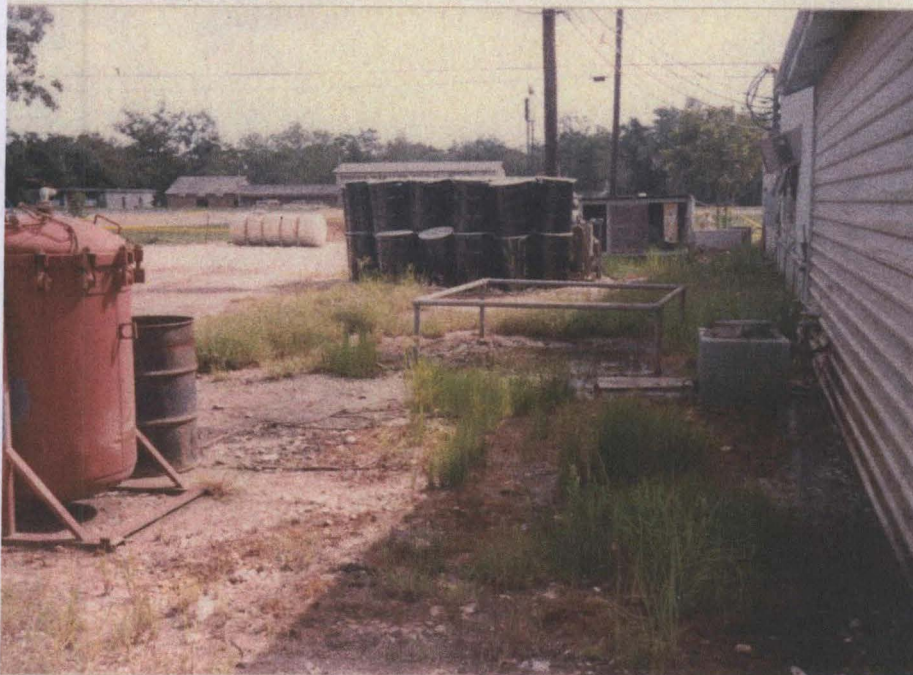
Photographer/Witness # 16

Comments: Spill area on the BES
parking lot covered with sand. In the
back, vacuuming of PCB oil from the off
site ditch in progress.

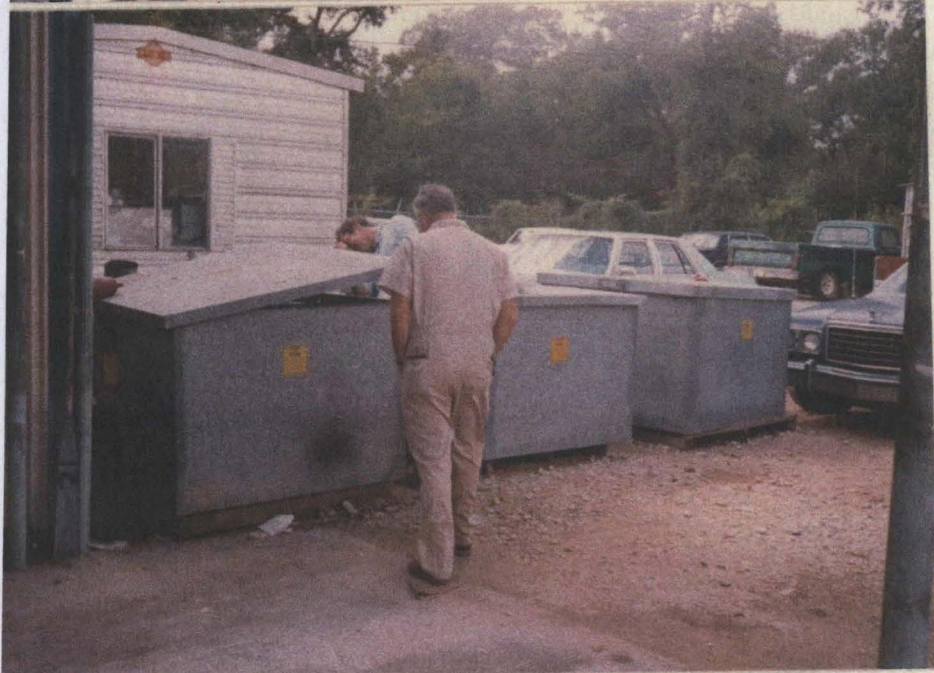
Comments: Metal containers that
store 55-gallon drums containing PCB
wastes on BES property.

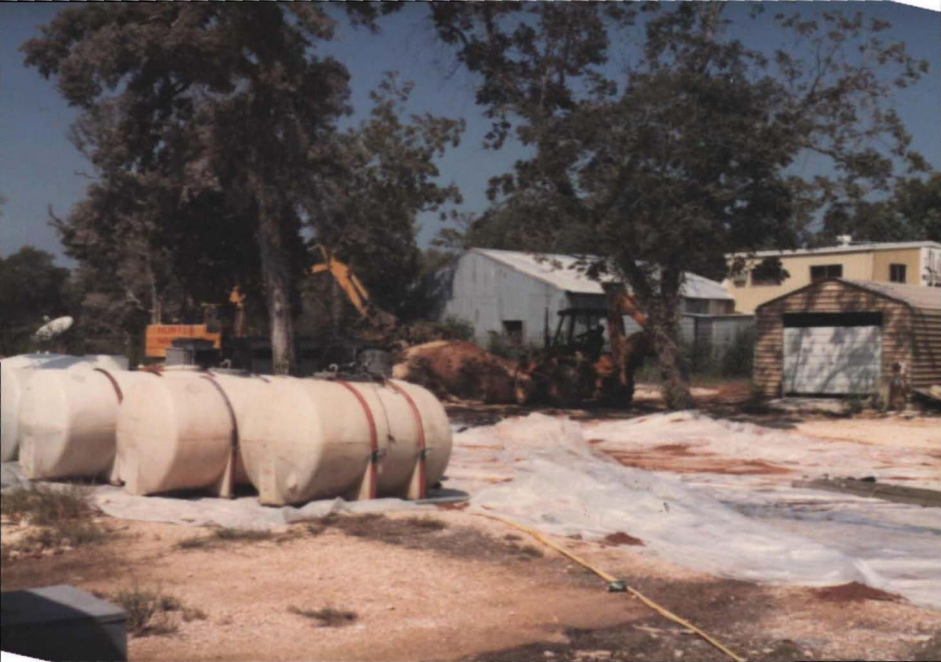
K-18
9/24/85
1040

The PCB-contaminated soil from
the hot spots on site is
added to the dirt pile.

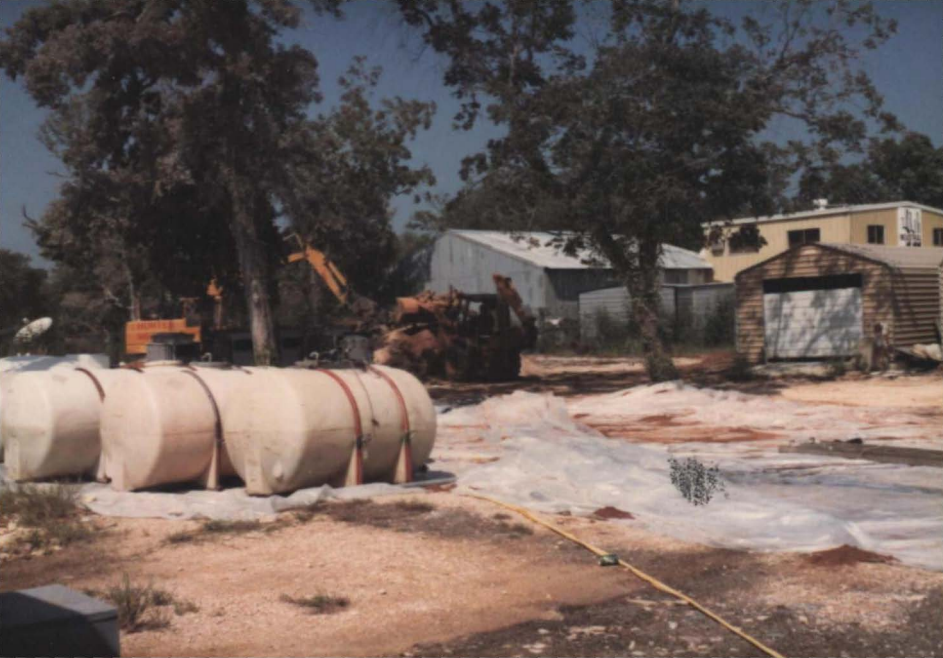
K-16
9/24/85,
1045-
Northwest

Another view of top soil excavation
for PCB hot spots
around the spill area
on the BES parking
lot.

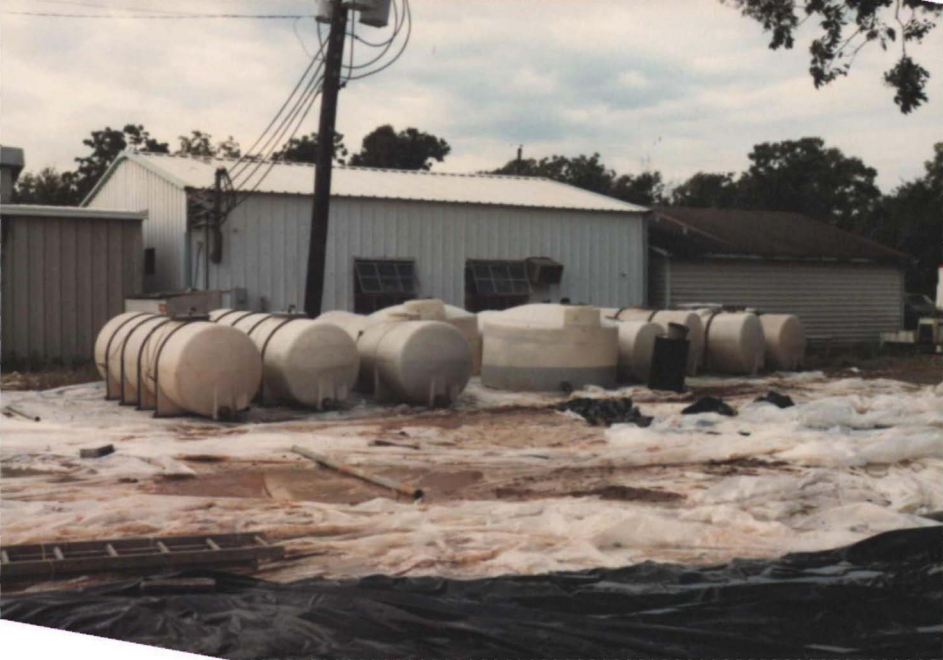
K-33

Skid Tanks that contained
PCB contaminated water from
the ditch placed on plastic.
Some tanks were locked
while others were not.

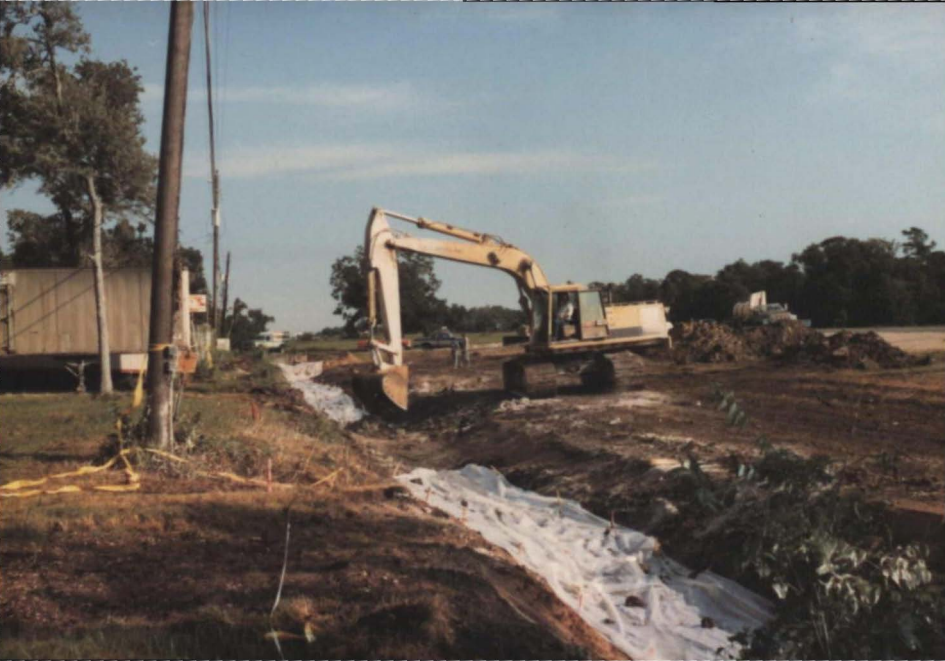
K-31
8/26/85
0920 hrs.
North

F-1 a g 12 + 13. 40' area that
did not get excavation on
9/25 is being dug out.
Plastic is removed before
digging.

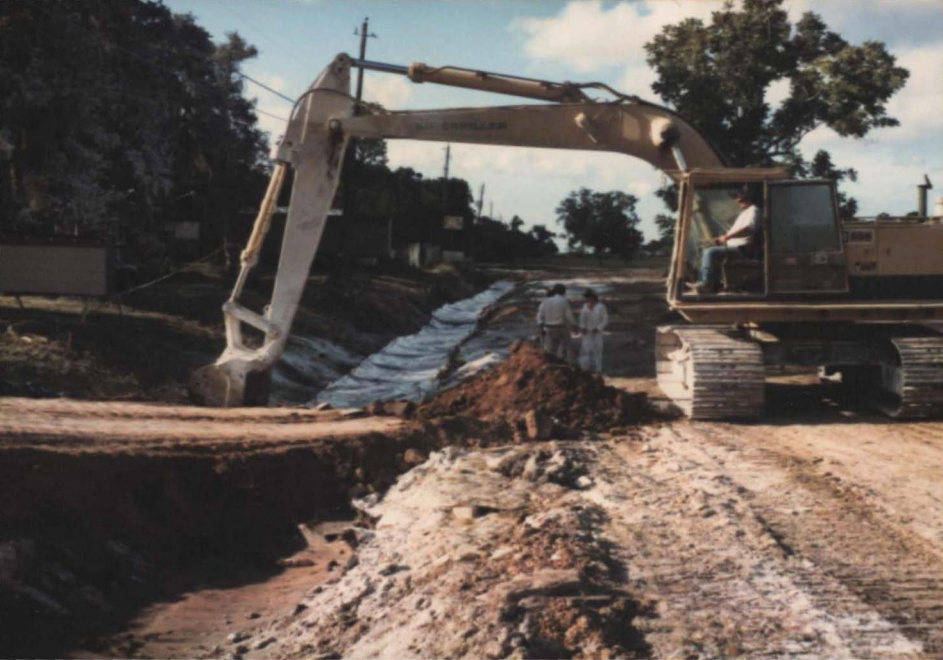
K-30 9/25/85

Flags #2 to #21 area covered
with plastic after excavation to
protect from rain until sample
results are received

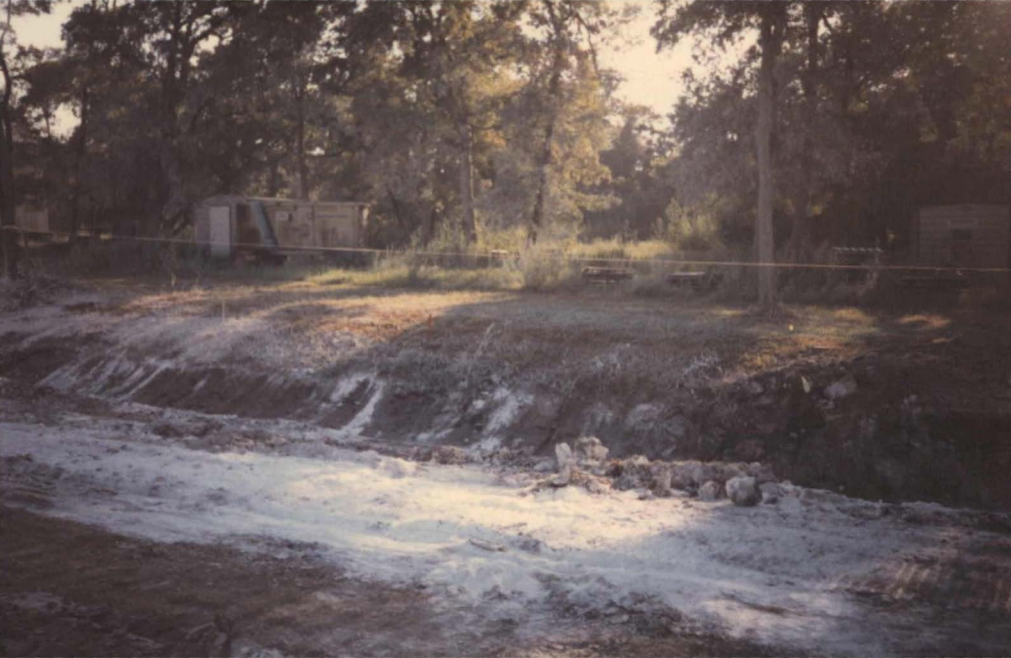
#17

Clear culvert south of
middle section about
to be sampled.

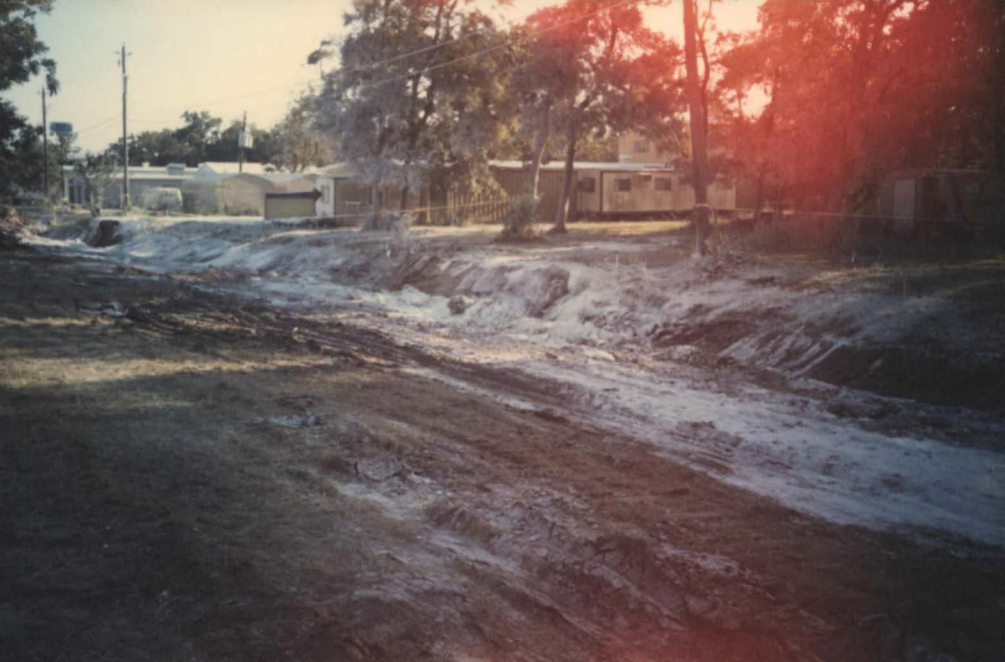
#16

middle section of ditch
is clear and
about to be sampled.

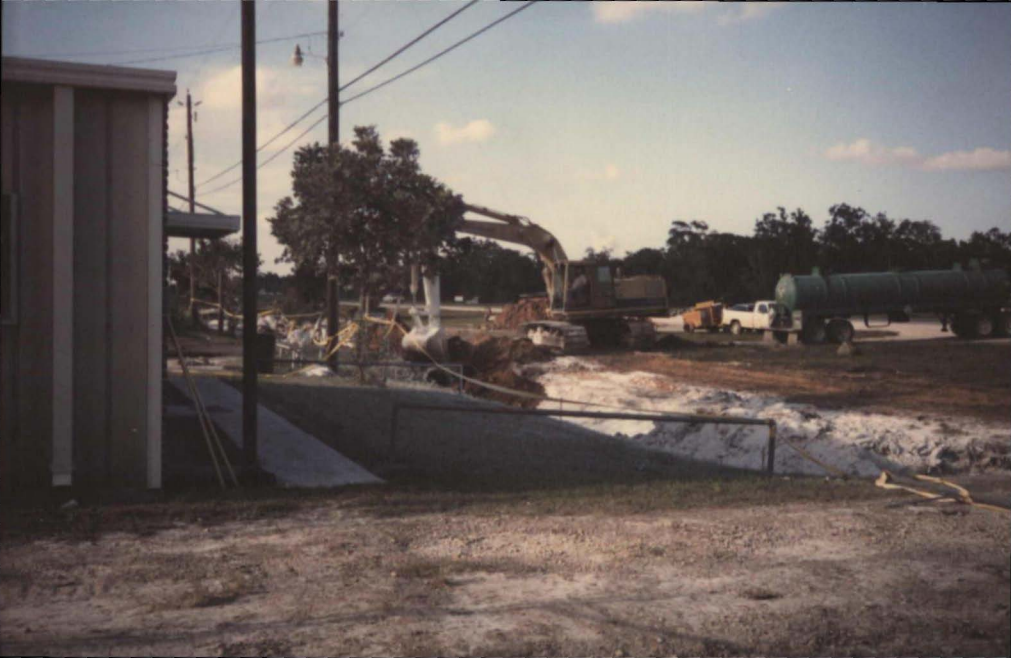
#11

Trackhoe breaking
culvert pipe. Pressure (downward)
was applied to bucket
resulting in breakage
of concrete pipe

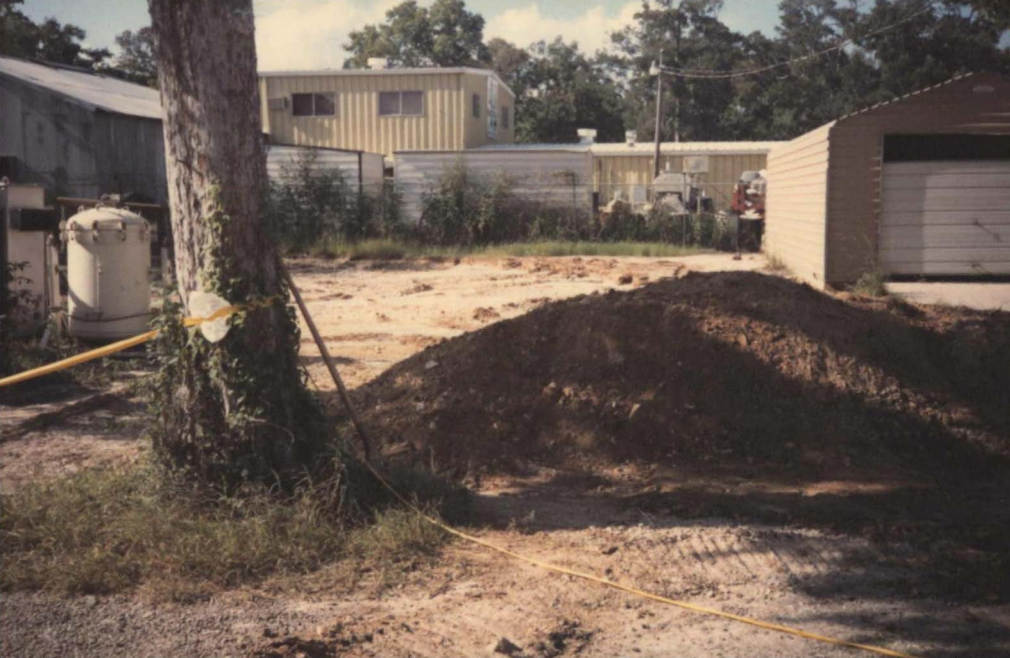
#10

Second smaller pile of
soil formed on
BES property

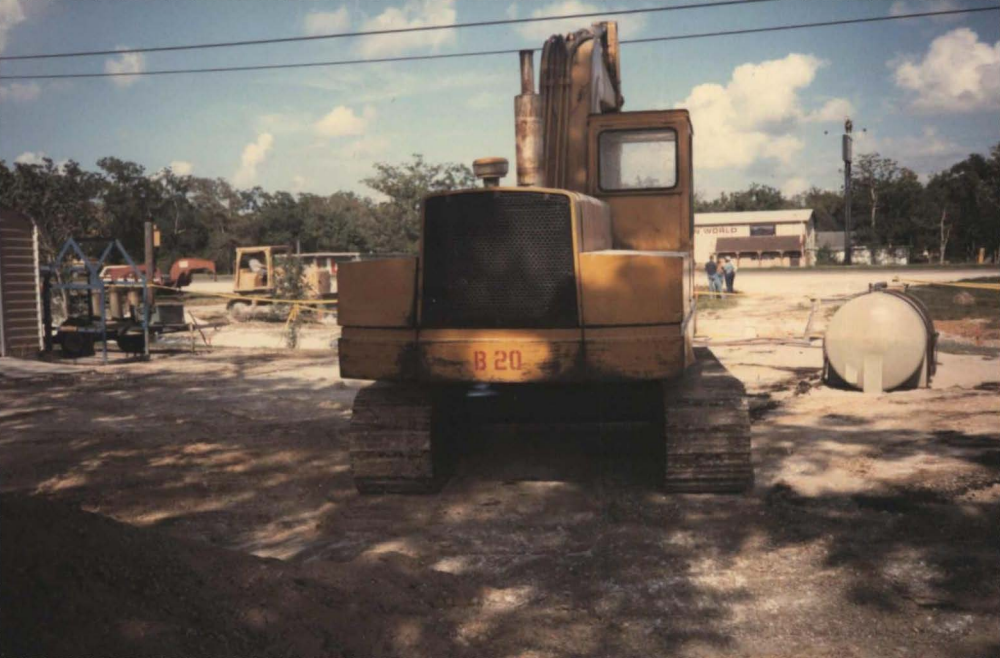
#9

Yard cleaning almost
completed.

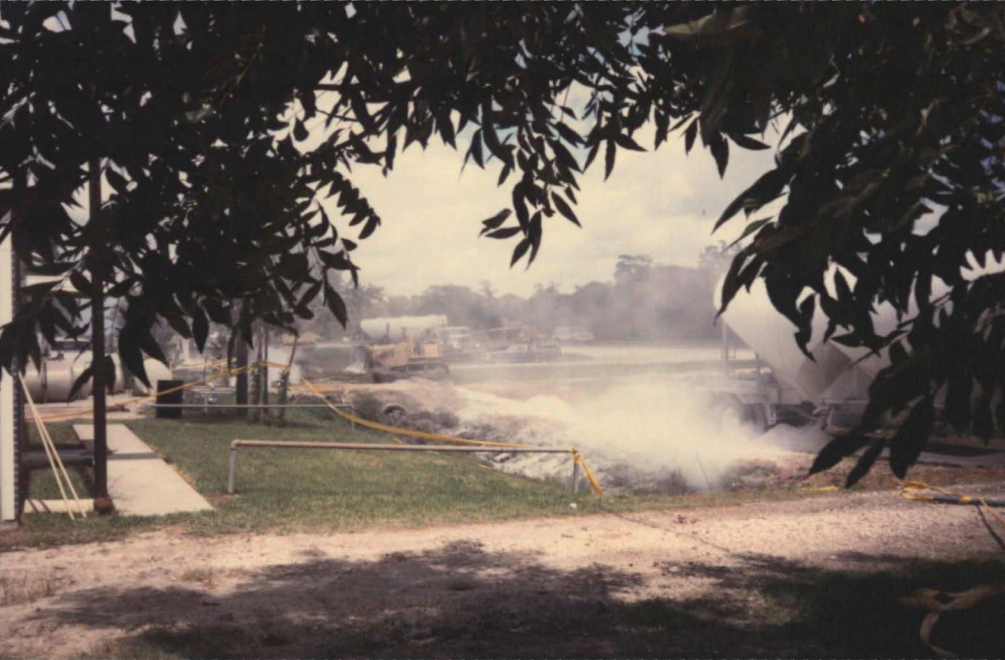
#3

Liming of ditch in
front of BES property

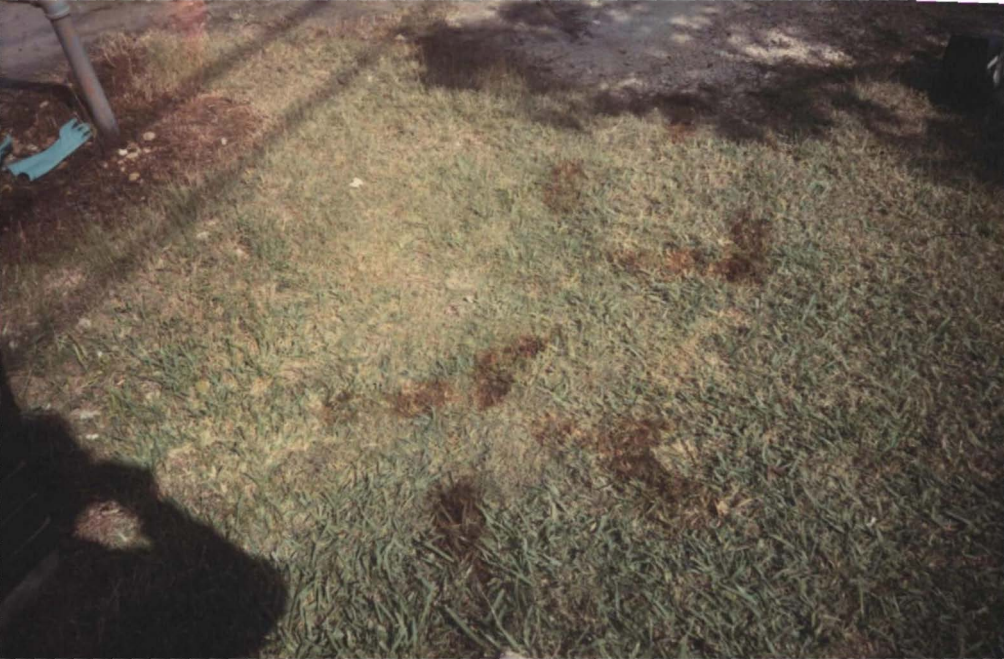
24

Burned grass from
oil on boots.

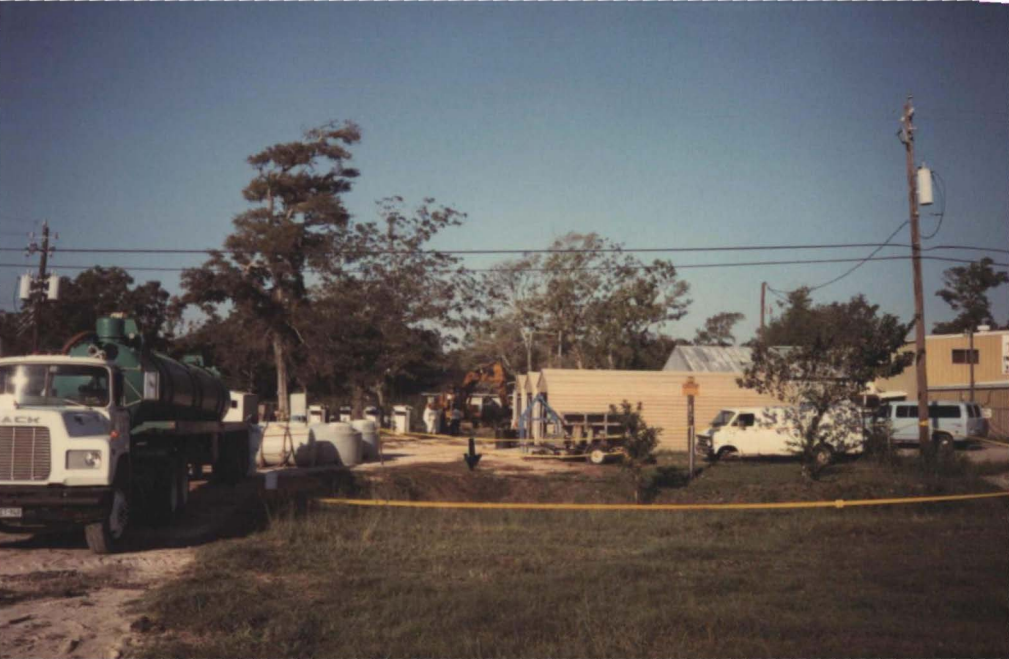
21

Vacuuming oil from
area of heavier accumulation.
Spill entered dilut arrow.

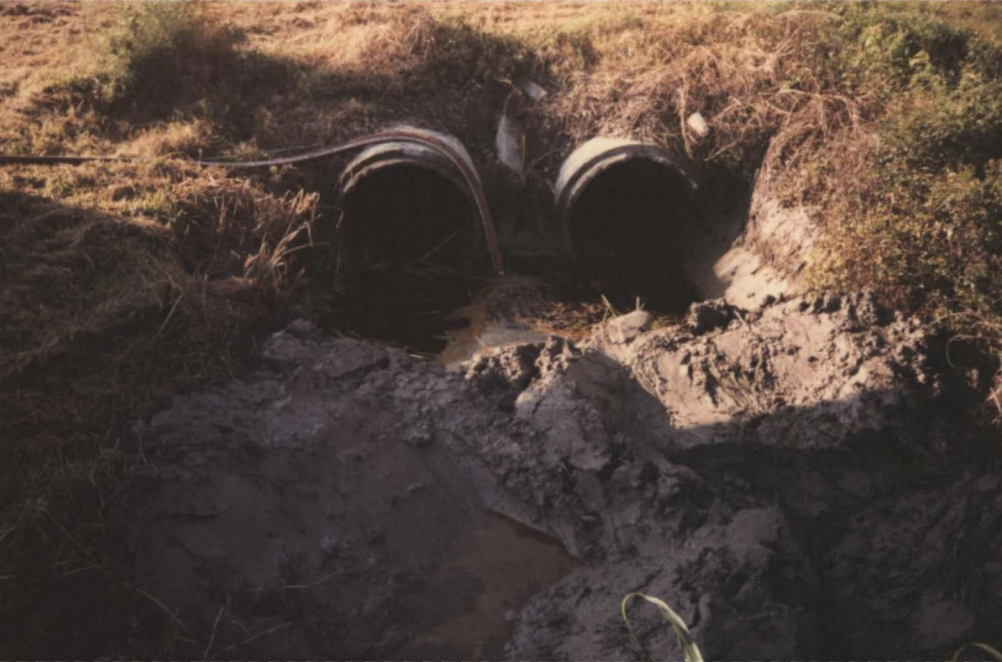
20 0837 - 0840 9/21/86

Vacuuming of water and
oil after trackhoe
has pushed it
to one end of
ditch segment.

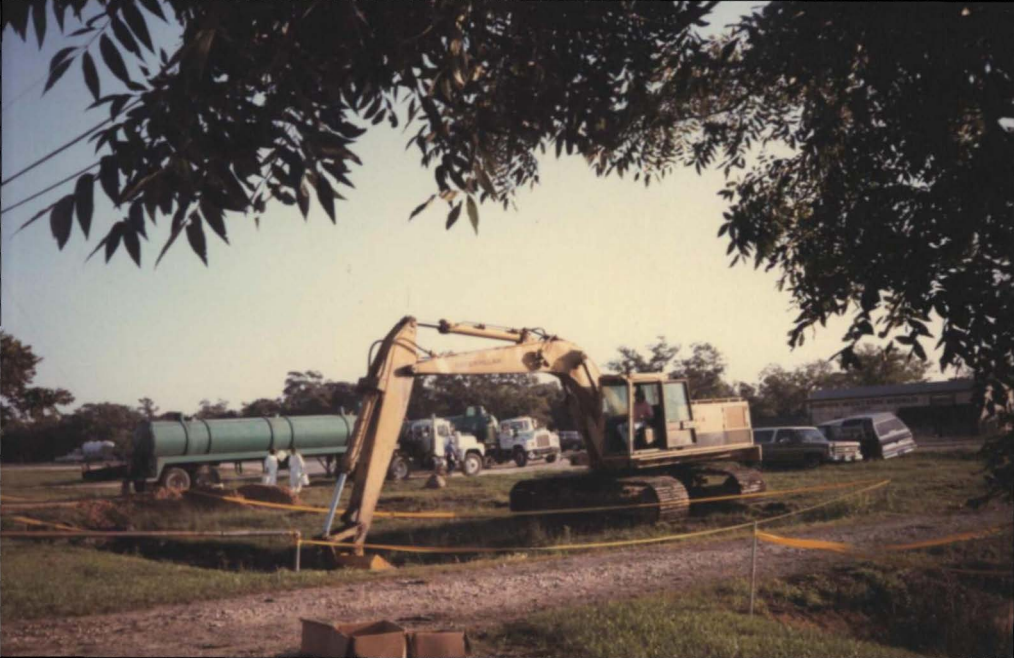
#18

Trackhoe pushing
water toward vacuum
truck for collection

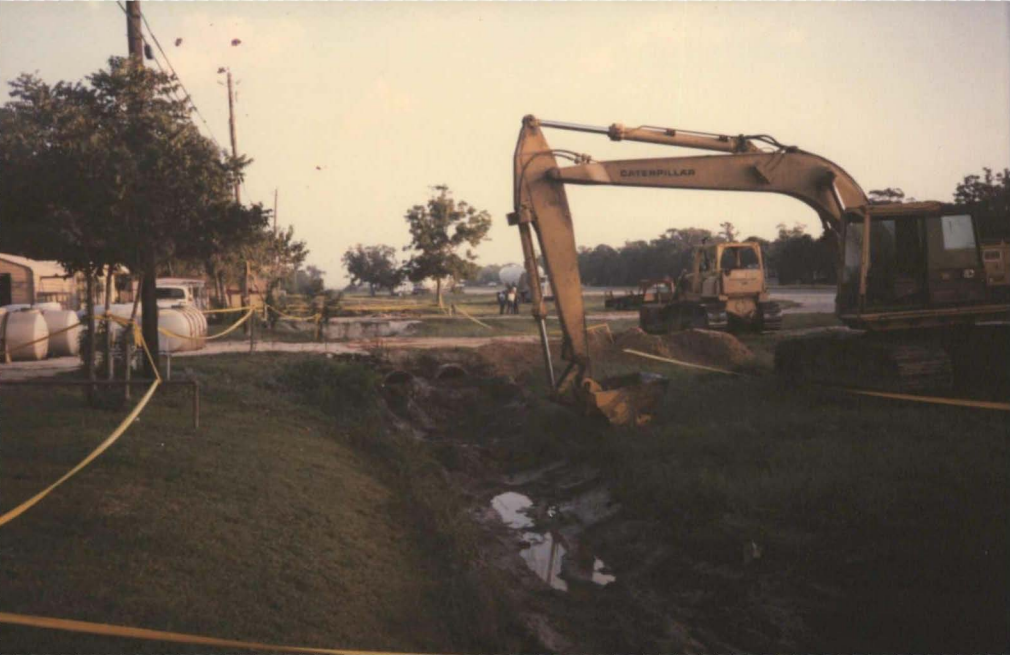
#17

Water remaining in
ditch after vacuum
and track hoe operation
North view

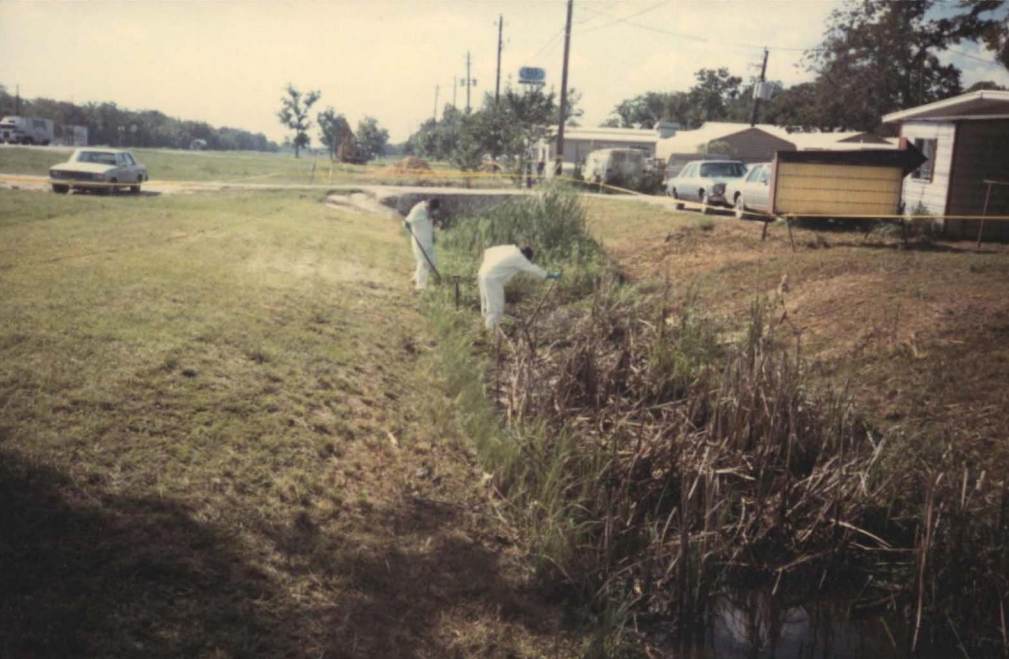
#13

Two workers cleaning ditch

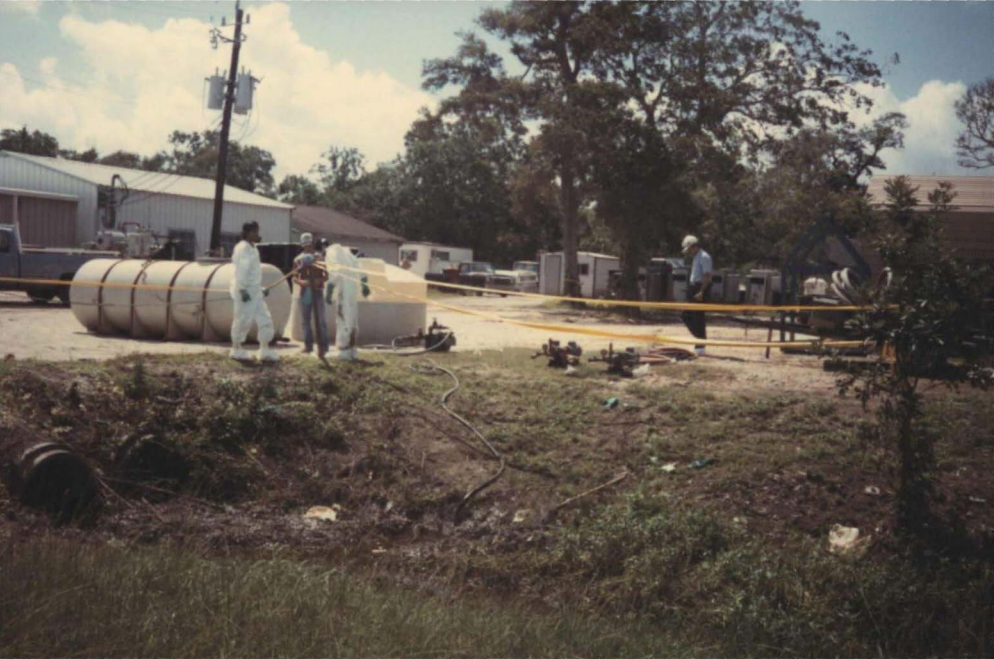
#10

Pump used to collect
PCB oil from ditch

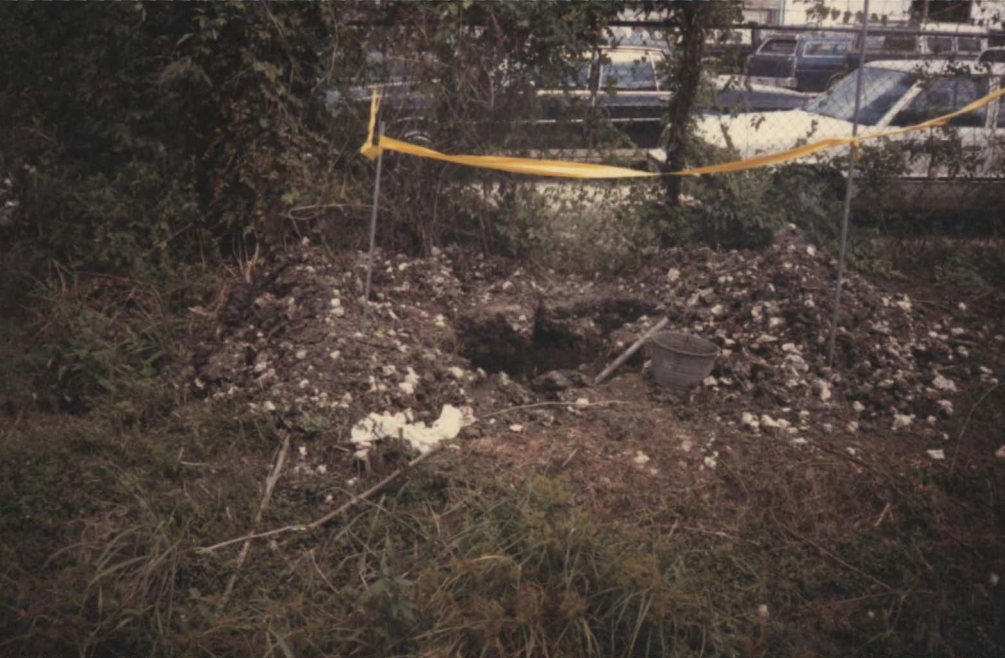
#2
1235-1250

Small Puddle of Sewage
in Southwest corner
of property.

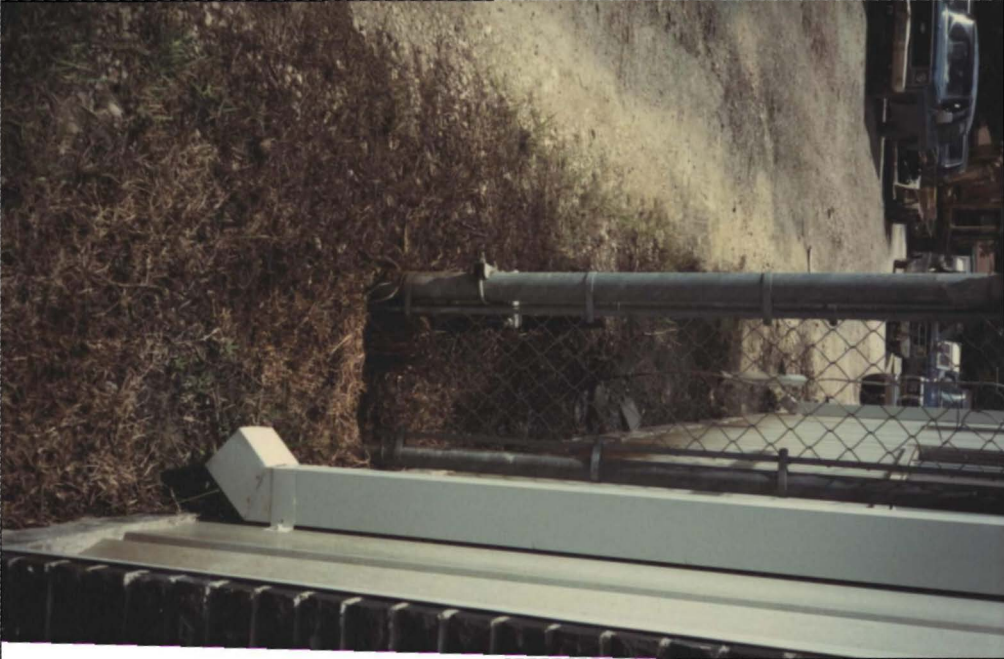
#5

Stained soil near
building was applied
for weed control.

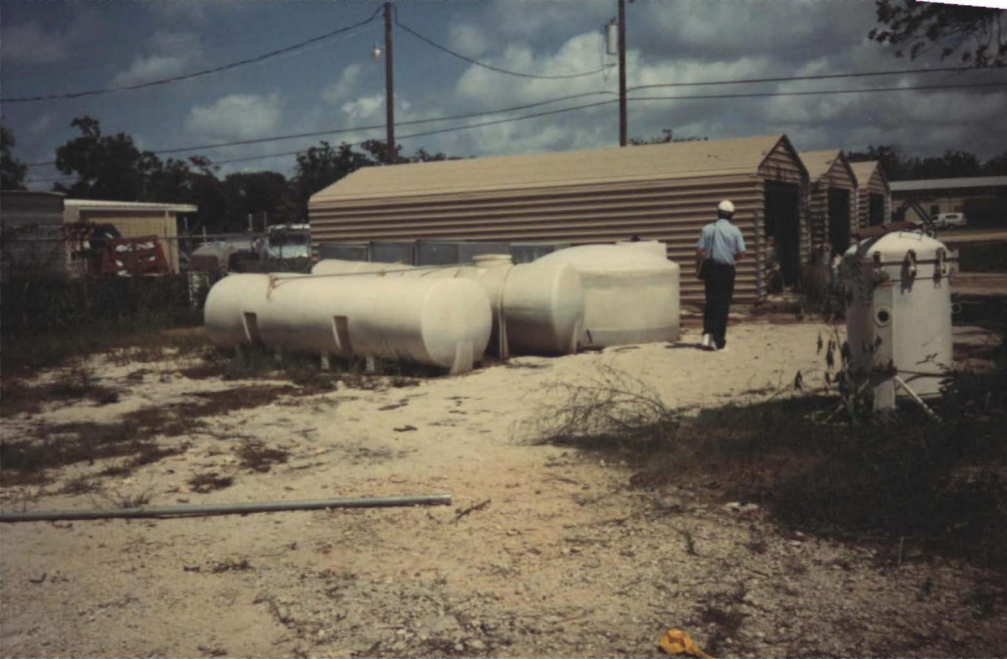
#6

Storage tanks that
were vandalized

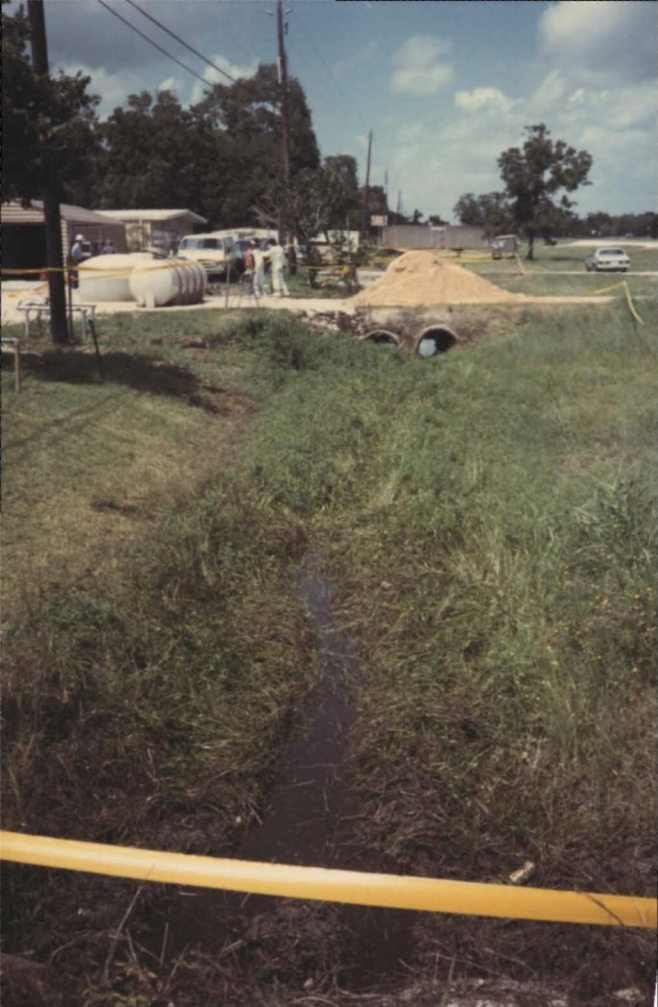
#8

A ffected drainage
ditch bordering
BES property

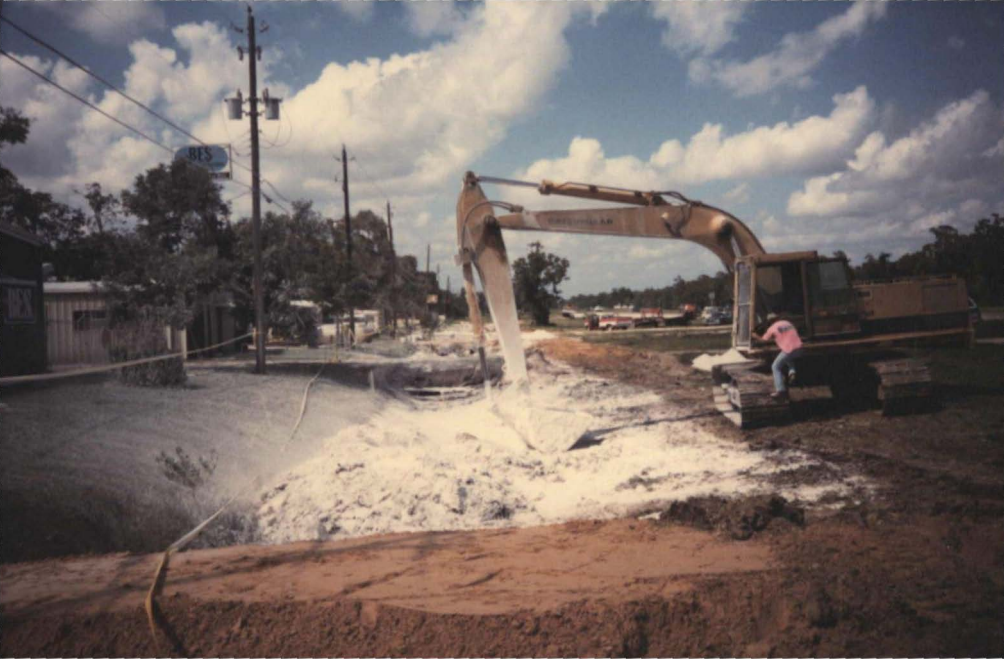
#6

Track hoe mixing the
lime and soil. Mixing
began with liming (1023 hr)
and was completed 1447 hr.

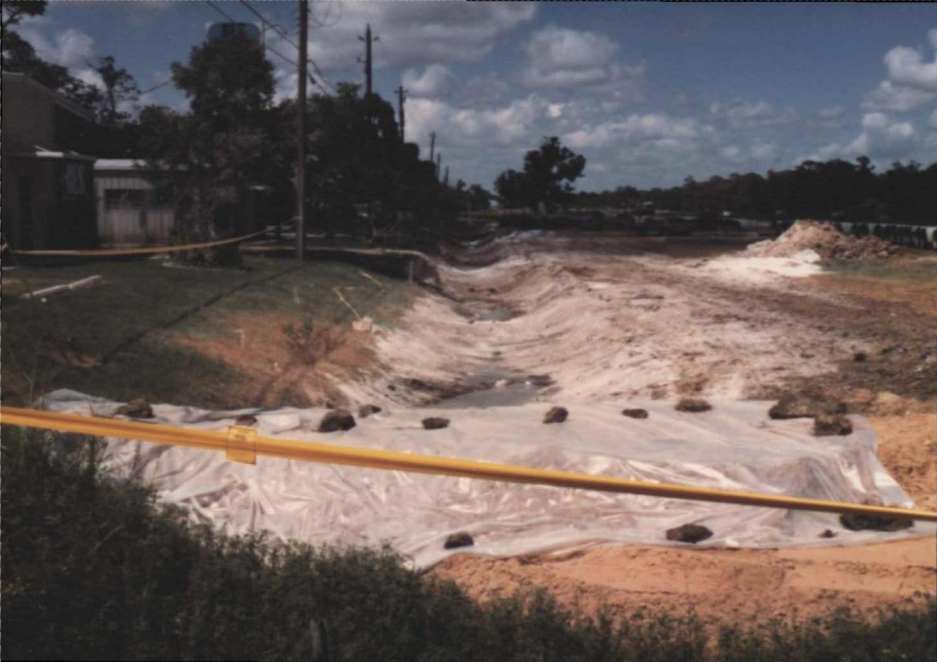
K-27

Another view of PCB contaminated ditch. Photo is looking north from south copper dam.

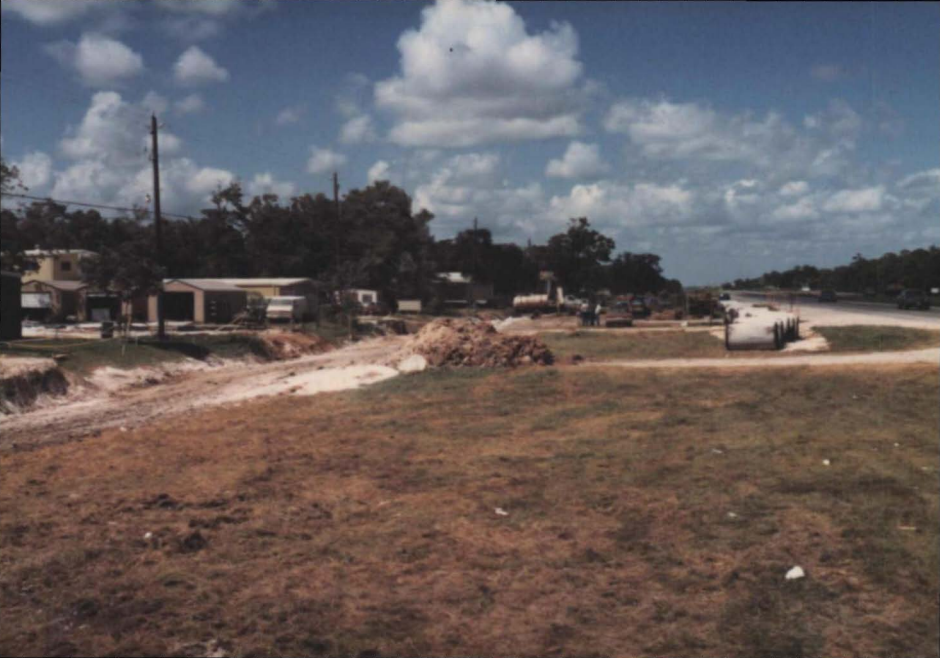
K-26

A panoramic view of offsite
ditch being pumped and
excavated for the second
time.

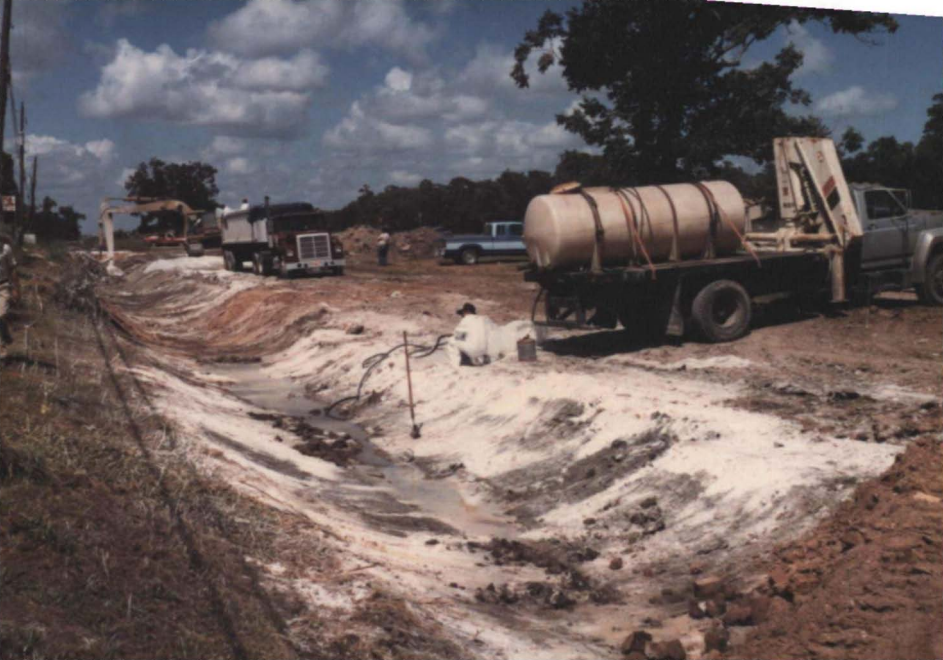
K-25
9/25/85
1350 lbs.
North

Standing water from showers
night of 9/24 being pumped
out.
